## EXTENDING LIFETIME OF WATERWALLS IN A SUPERCRITICAL BOILER

*KEYWORDS: supercritical steam boiler, Alloy t24, corrosion protection, thermal spray.*

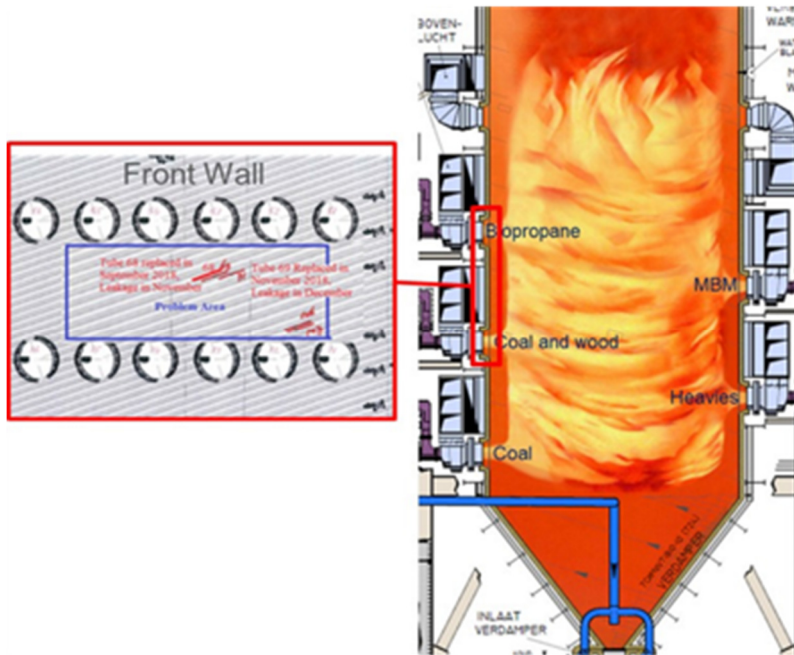
The boiler has five rows of six burners on two sides. These burners are fed with coal, bio-propane, wood, and MBM (Meat and Bone Meal) - animal residue foam injected into the boiler. MBM is very erosive, so the flow is deviated by a deflector plate in the burner, however, the spray still impacts on the opposite wall generating localized erosion and corrosion due to a small deposits on the wall facing the MBM burners.

*Uniper Maasvlakte Boiler Schematic*

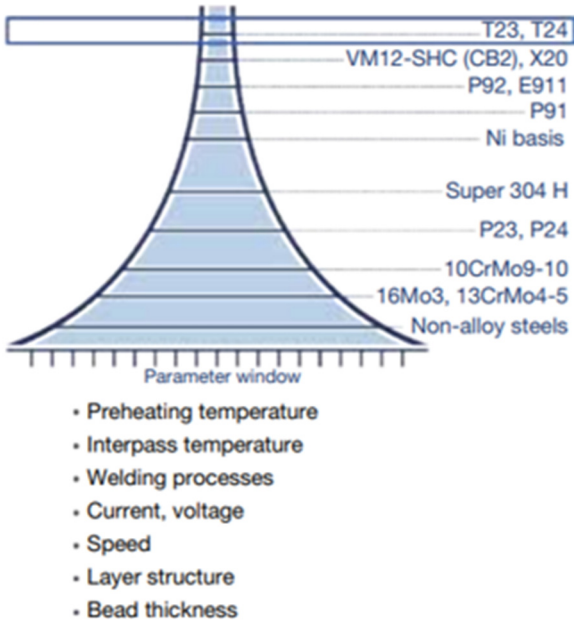
Welding this superalloy is difficult, especially without annealing or post-weld heat treatment. Non-alloy steel, a material used to produce typical boiler tubes, PH 265GH, is the easiest material to weld. The superheater material, 10CrMo9-10, is known as a more difficult material to weld and requires good welders with specific procedures to follow. P91, a refinery furnace tube material, is still more difficult to weld, T24 is even more challenging.

### *Welding Difficulty of Different Alloys*

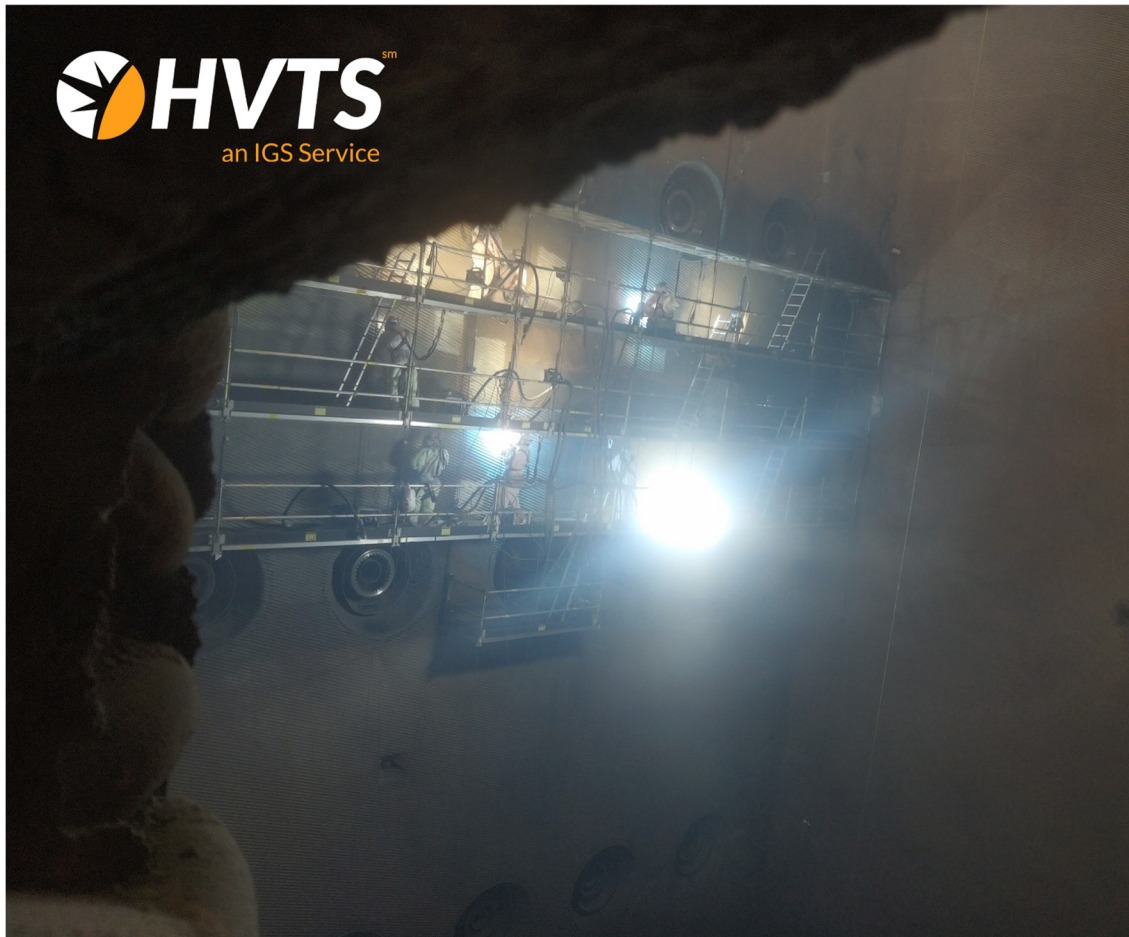
As Uniper Maasvlakte continued having multiple stoppages due to leaks, in 2019, they decided to apply a protective cladding onto a test area to evaluate its performance. [IGS HVTS](#) was chosen for this on-site job. [HVTS](#), or High-Velocity Thermal Spray, is a combination of a superalloy

material, application process, and a conveyancing system developed by IGS (Integrated Global Services) to protect boiler pressure parts.

#### *IGS HVTS – High-Velocity Thermal Spray*

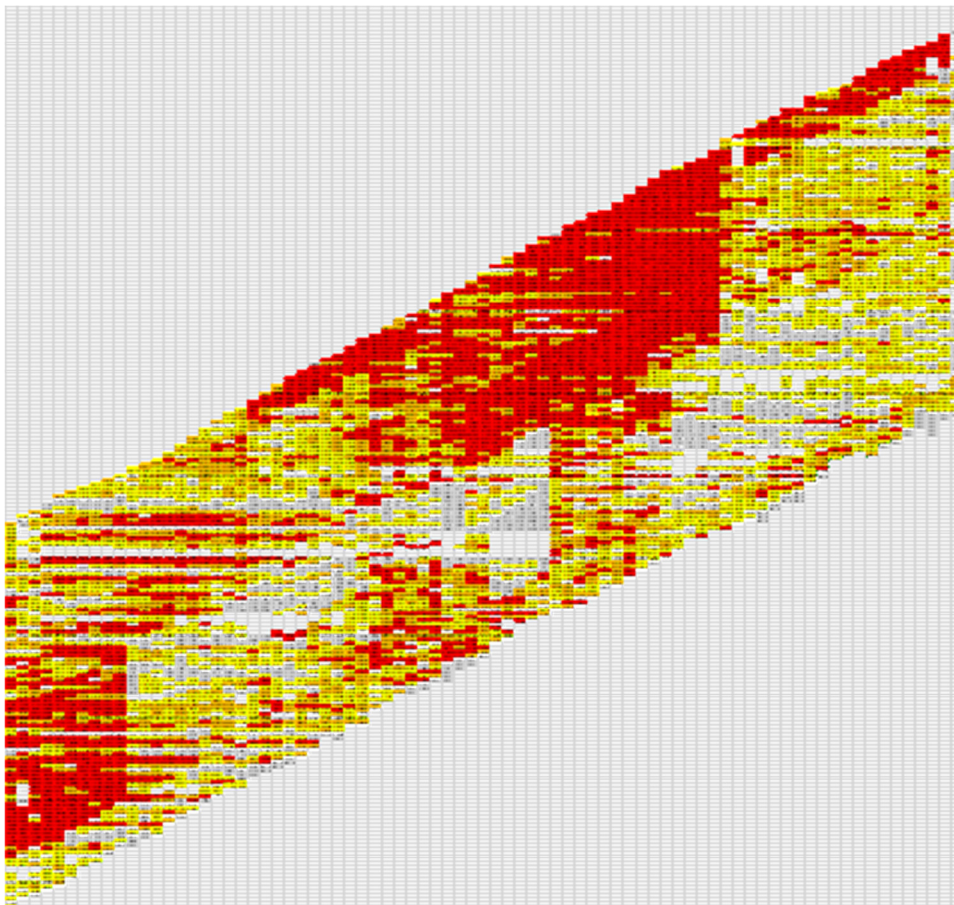
UT Quality inspected HVTS cladding and unprotected tubes. They performed tube scanning using a PEC Scan, Pulsed Eddy Current scanning, that delivers specific tube thickness mapping. This inspection was conducted in 2019 and again in 2021. By subtracting the data collected from the two inspections, they aimed to identify the thinning of the tubes and predict further thinning expected in the next few years.

The area protected by HVTS cladding experienced much less thinning. However, above the protected area, unprotected tubes had shown a thickness loss of up to nearly one millimeter per year.

*Thickness change between 2019 and 2021: Red change >0,51 mm, Orange change: 0,31-0,51 mm, Yellow change: 0-0,3 mm*

When comparing inspection results between 2019 and 2021, the inspection company immediately noticed that some areas appeared to have gained thickness. *Cyril Narjoz, IGS [Boiler](#)*

Reliability Expert, commented: *“You need to keep in mind that first of all, you never read the same point two years later, it's impossible. Even when you do the reading on the same spot, during the same inspection or the day later, you already can have some significant variation. Readings in 2019 were taken at the three o'clock position, whereas the readings in 2021 were taken at the five o'clock position.*

The inspection results were matched with the positioning of the HVTS cladded area. It was a challenge because it didn't match the red area or the colored area of the thinning. Moreover, to make it a little more complicated, in this boiler, the tubes are not vertical. They are positioned at an angle, spiraling around the boiler. When scanning is performed, they cannot scan horizontally or vertically, but have to follow the tubes.

*Cyril added: “Nevertheless, what we can see in the area where we applied the HVTS the cladding, there's much less thinning. And above the area, we have this red zone where we can notice up to nearly one millimeter per year loss that becomes critical.”*

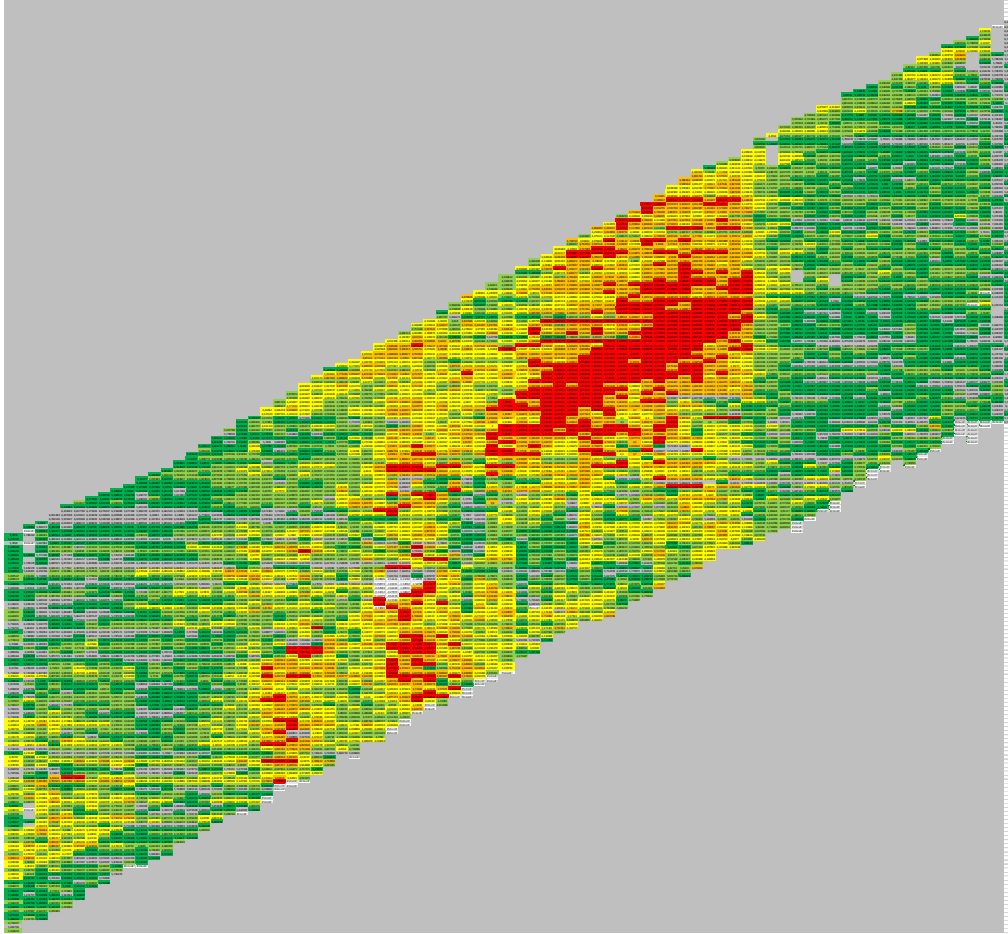
### *Thickness Change Prediction for 2023*

Initially, prior to evaluating the readings, Uniper had commissioned IGS to expand their HVTS cladding scope to protect a 35 m<sup>2</sup> surface area finishing the band and protecting a band below. However, after evaluating the readings and the wear rate predictions, the turnaround team decided to increase the scope in the critical area up to 85m<sup>2</sup> projected surface area.

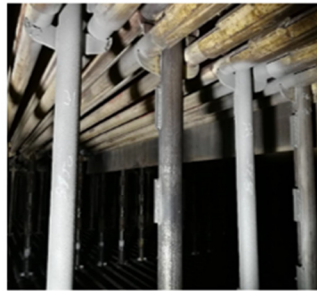
Fig. 8 – single tube #31 sprayed with IGS B450; #33 sprayed with IGS S475

Applied on site in August 2019

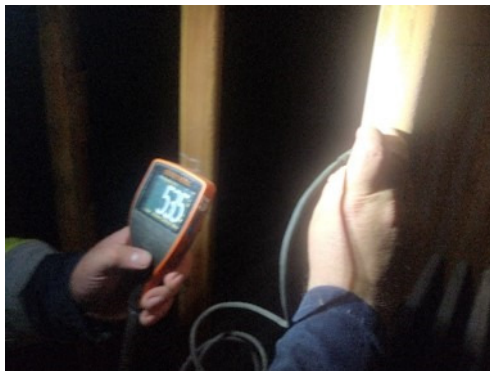
Two tubes were clad with IGS [HVTS](#) in lieu of protective shields. After two years in service, physical inspection confirmed HVTS cladding to be intact, with no thinning or damage.

*HVTS Cladded Superheater Tubes Inspected in 2021*
