## New Chocking Compound Keeps Vibrations at Bay

At a port operator in the UK, an extremely durable chocking system was required to ensure a new boiler would remain secure and protected, even when subjected to aggressive vibration activity.

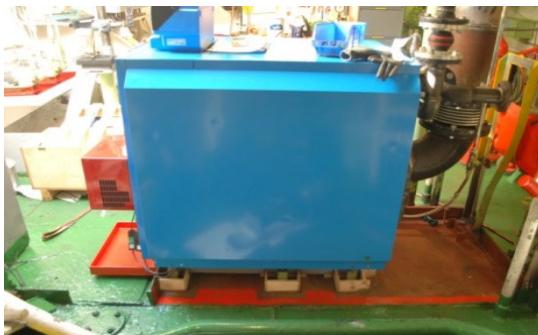
1. Boiler set in place

The boiler was set into place using jacking bolts, and dams were built around each of the individual bolts in order to ensure a restricted chocking area. Belzona 7111 was then poured into the prepared areas.

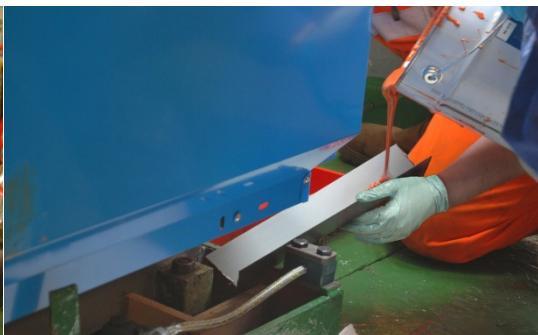
2. Pouring Belzona 7111 into the prepared area

Due to the way in which the boiler sat inside the engine room, there was limited access underneath which made it difficult to pour the product directly from the mixed unit into the chock area. A small curved steel section was therefore used as a channel to funnel the product, with a thickness of just over 2 inches, into the correct area. Once the application was completed and the system had cured, the dams were removed.

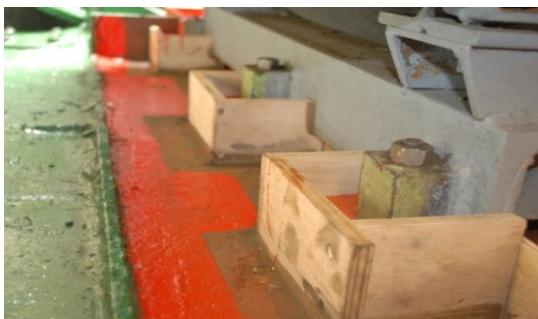
3. Product curing around bolts

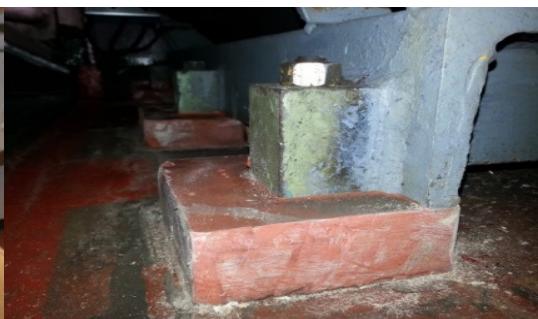
4. Completed application with dams removed
