## PRESS RELEASE HAW05

## Hoist & Winch elevates success of large construction project

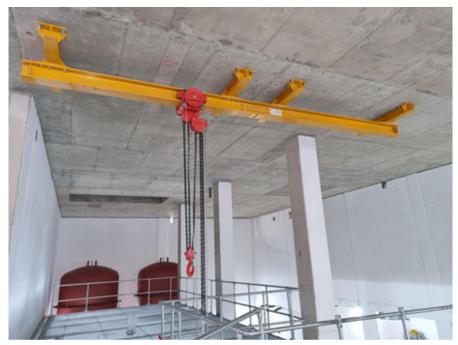
Concrete ceiling mounted 7.5t swl lifting beam and manual chain hoist recently installed by Hoist & Winch Ltd into the basement energy room of a large new tower block.

The requirement was to install a concrete ceiling mounted 7.5t swl (safe working load) lifting beam and manual chain hoist into the basement energy room of a large new tower block. This development is part of a large-scale prestigious regeneration project providing 5500 sustainable new homes in North London.

At the design stage, following formal tender and contract award, Hoist & Winch set about identifying the optimal solution. Due to restricted access into the basement area, the company decided to utilise a two-piece lifting beam design with an overall length of 7m. To join the two lifting beam sections, Hoist & Winch designed a central splice joint of bolted construction with a reinforced bottom beam flange.

In order to spread the lifting loads over a greater area of the concrete ceiling slab it was decided to mount the lifting beam via four intermediate cross members, each having a four-bolt/anchor fix into the concrete ceiling at both ends. Featuring a robust bolted construction design it was possible to deliver the lifting beam to site in fully dismantled form for ease of transportation and access.

M24 resin anchors with an embedment of 255 mm into the 400 mm deep reinforced concrete slab fixed the intermediate cross members directly to the ceiling for maximum security.

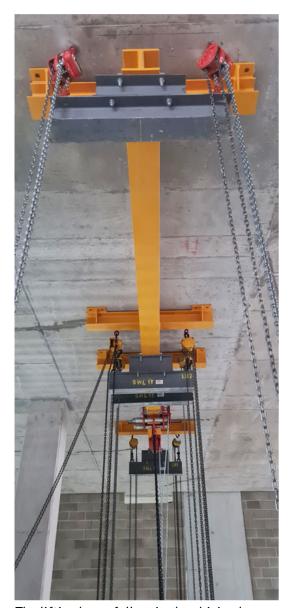
The lifting beam fully raised and joined.

The first lifting beam section manoeuvred into position also included the 7.5t swl hand chain block, which was rolled on to the lifting beam at low level using a 1t swl hand chain block temporarily suspended from local steelwork. Once both lifting beams were in position, Hoist & Winch joined the two lifting beam sections using the aforementioned bolted splice plate.

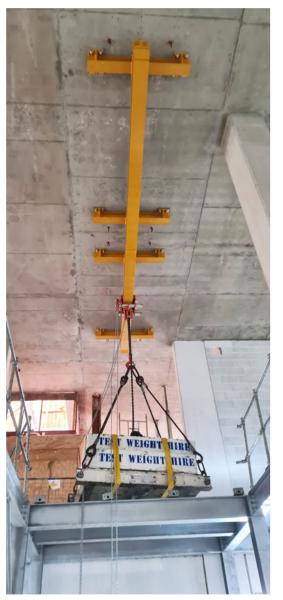
The lifting beam fully raised and undertaking load testing.

The final installation and test operation was LOLER (Lifting Operations and Lifting Equipment

Regulations) inspection of the lifting beam and manual chain hoist unit. This activity included

dynamic load testing of the entire runway beam length with a 7.5t skid-mounted test load followed

by 125% static proof load test in accordance with BS 2853 2011.

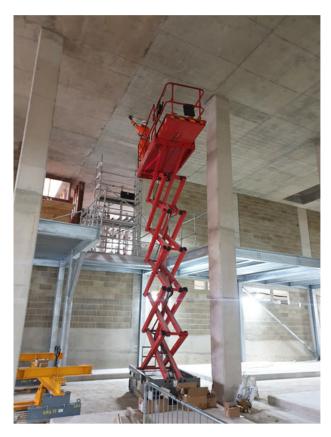
A vital part of the project was the installation line of the lifting beam being marked out while working from scissor lifts.

With the design approved, Hoist & Winch could progress to manufacturing, followed by delivery to site. Using building column positions as datum points, the installation line of the lifting beam was marked out while working from scissor lifts and an aluminium scaffold tower located on the upper mezzanine floor. A surveyor's laser line initially identified the correct lifting beam position, prior to overlaying with red chalk to ensure accuracy for the duration of the installation work.
